# Manhole Inspection Summary

Manhole # S45W\_\_012MH

Insp Date: **3/12/09 2:27 PM**

**Location** Address: **1335 andre st**

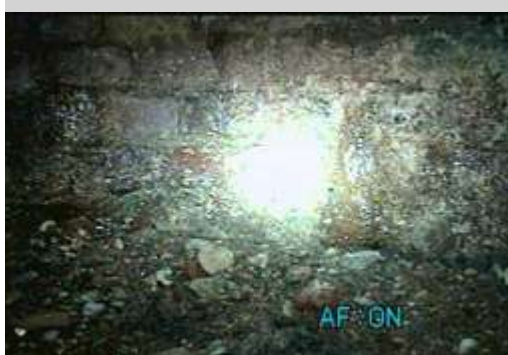
Defect 5

Infiltration: ☐ None ☐ Joint ☐ Cracks ☐ Mortar ☐ Roots ☒ **Wall**

infiltration from barrel wall

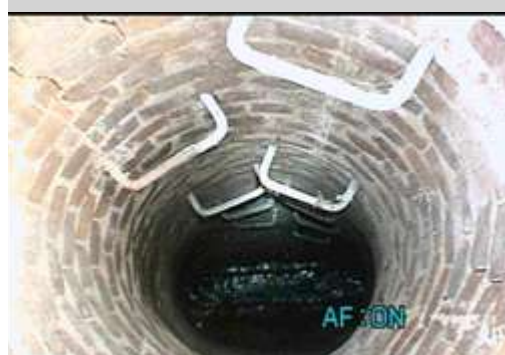
Defect 3

Count: **9** Missing: **0** ☒ **Corroded**

corr steps

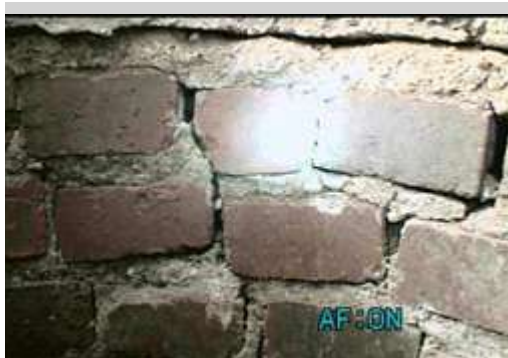
Defect 2

Condition: ☐ Sound ☒ **Cracked** ☐ Root Intrusion ☐ Loose Brick ☒ **Deteriorated**

corbel cracked & deteriorated

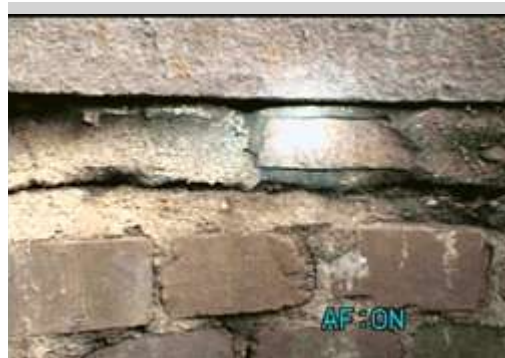
Defect 1

Condition: ☐ Sound ☐ Cracked ☐ Root Intrusion ☒ **Loose Brick** ☒ **Deteriorated**

chimney deteriorated with loose brick

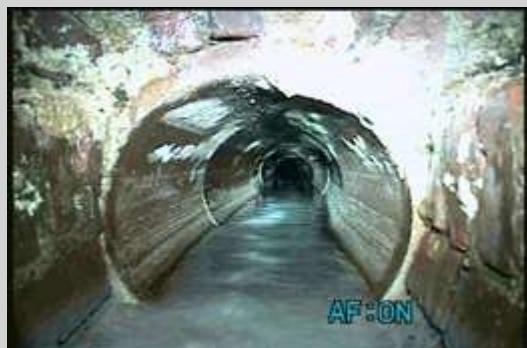
12 O'Clock Outflow

10 in. Circular Gravity Sewer  
Pipe Out @ 12 O'Clock

Deposits: ☒ None ☐ Mud ☐ Sludge ☐ Debris ☐ Grease

Infiltration: **None** Pipe Seal Cond: **Unknown**

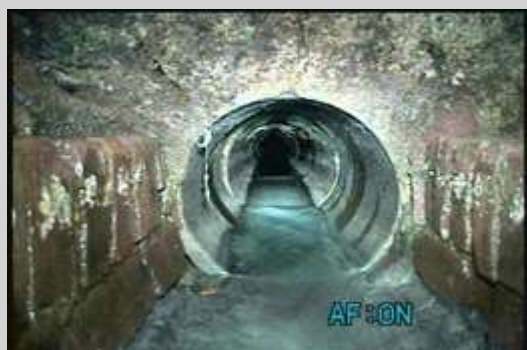
6 O'Clock Inflow

10 in. Circular Gravity Sewer  
Pipe In @ 6 O'Clock

Deposits: ☒ None ☐ Mud ☐ Sludge ☐ Debris ☐ Grease

Infiltration: **None** Pipe Seal Cond: **Unknown**
